Distribution System Hydraulic Modeling Analysis Examines System Issues and Identifies Operational Solutions

By Robert T. Mackie, P.E., BCEE*, Blake D. Lukis**, Ashley N. Dunn, P.E.***

Presented April 1, 2015

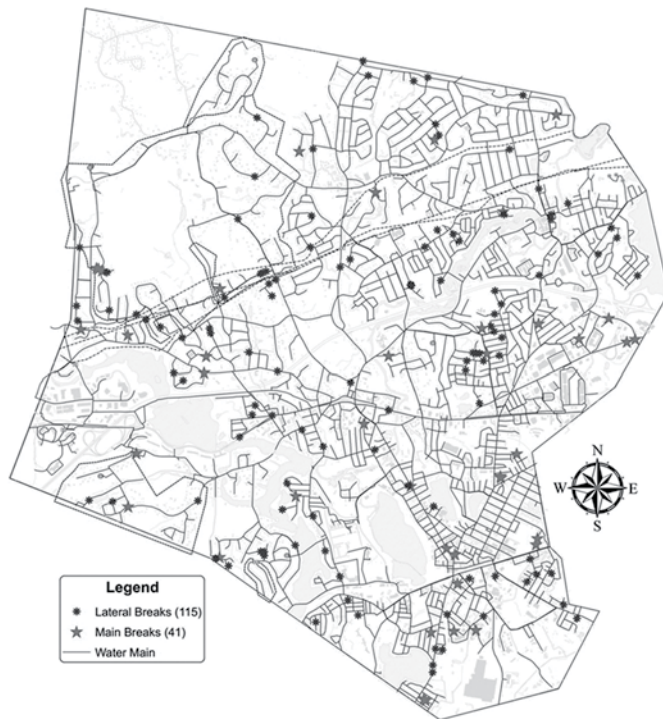
Figure 6. Breakdown of water main breaks in the Town of Framingham

role in the high incidence of water main breaks. Record data confirmed that old cast iron pipes in the system did in fact play a large role in the frequency of water main breaks. Cast iron pipes installed prior to 1950 accounted for 24 percent of water main breaks while cast iron pipes installed between 1950 and 1975 accounted for 61 percent of water main breaks.

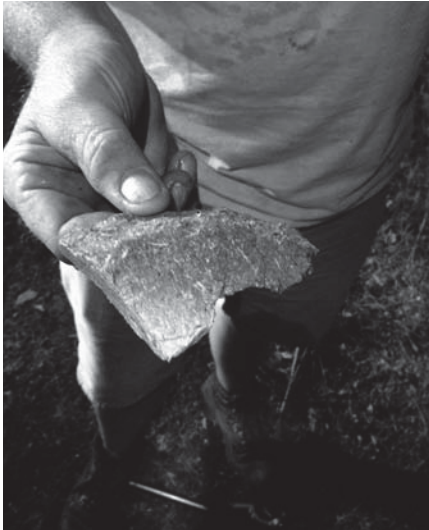
Figure 8. Debris from water mains

BETA worked with Town field personnel to implement a testing program over two weeks. Testing was generally conducted at night to minimize disruption to residents and businesses. Field testing consisted of hydrant flow and pipe condition testing. During calibration and flushing exercise, a lot of debris was flushed from the system. Figure 8, Debris From Water Mains, and Figure 9, Pitot Tube Fragment From Water Mains, show how some of the debris that came out of water mains during this flushing exercise and damaged the pitot.

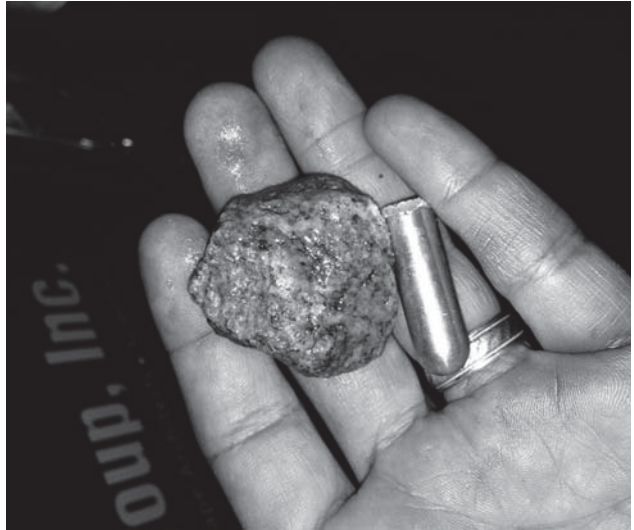
Figure 9. Pitot tube fragment from water mains

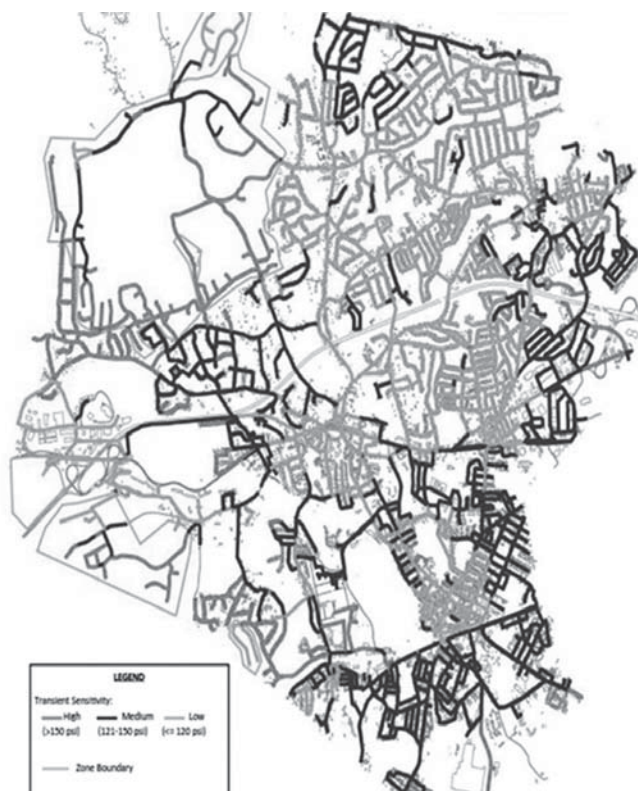
Figure 10. Likelihood of transients in the Town of Framingham water mains

for water hammer. The modeled system was analyzed for water hammer by simulating the operation of hydrants for either fire or maintenance condition by applying an instantaneous flow followed by a quick shutoff at various locations throughout the distribution system. Transient pressure experienced by a pipe varies and fluctuates depending on the location and magnitude of the source of the transient. This figure shows the compilation of reactions observed in the distribution system after numerous transient analysis model runs were conducted. The water hammer analysis identified areas of low, medium, and high water hammer probability as shown in Figure 10, Likelihood of Transients in Town of Framingham Water Mains.

Green lines represent pipe where no issues were found, while blue areas had a moderate potential for water hammer. Transients within these pipes may need to be addressed in the future but were not a priority. Red lines on Figure 10, Likelihood of Transients in Town of Framingham Water Mains, indicated areas where there is high potential for water hammer of more than 150 pounds per square inch of

pressure (psi). In at least two cases, predicted transient pressure could be as much as 500 psi. New pipe properly installed is generally operated under 100 psi but may be rated for 250-350 psi. Transients pose a serious problem and identifying systems weak points has helped the Town prioritize repairs and minimize future water main breaks in known high-risk neighborhoods.

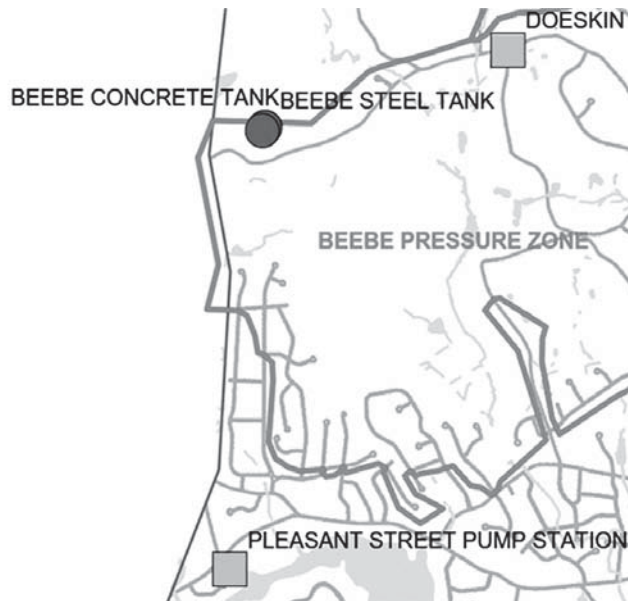
During the modeling, the project team discovered that one zone boundary (the areas of Angelica Drive and Lanewood Street) had dead ends that were very susceptible to water hammer. Pipes in this area were normally under low pressure of around 25 psi; however, if the pipe in this area was subjected to a water hammer transient it would expose the pipes to hundreds of pounds of pressure and almost certainly cause a break. This poses a real hazard as well as a major inconvenience to residents in the neighborhood and thus a high priority fix.

Figure 11. Proposed zone boundary shift

Findings of the transient modeling revealed that there was one zone boundary issue as briefly mentioned above. The boundary located south of the Beebe Zone at the Angelica Drive and Lanewood Street area creates a dead end

condition in both of these streets. Records indicated two water mains recently in Alan Street, a cross street of both Angelica and Lanewood, but this main is located outside the Beebe Zone in the Town Zone.

BETA developed a plan to mitigate the concern for transients in the area. They recommended moving the zone boundary to Alan Street. This creates a loop that alleviates the stress of the transient condition caused by the dead-end pipe sections. This also improves the average day condition water pressure on Angelica and Lanewood, which was low in the existing condition due to the dead-end water mains. However, it should also be noted, the water mains on these streets are cast iron of the 1950-1975 vintage and are susceptible to breaks and are recommended to be replaced as described above.

Figure 11 illustrates the revised zone boundary.

All zone boundaries were evaluated within the analysis and were generally found to be suitable, with the exception of one change in the boundaries of the Beebe Zone. This change would improve water pressure, eliminate two dead ends, and create a loop in an area of the prone to water hammer incidents (Figure 11). The pipe in this loop will need to be replaced as the existing cast iron may not hold up in the higher pressure zone. It is also recommended that the Town consider adding surge relief at key locations throughout

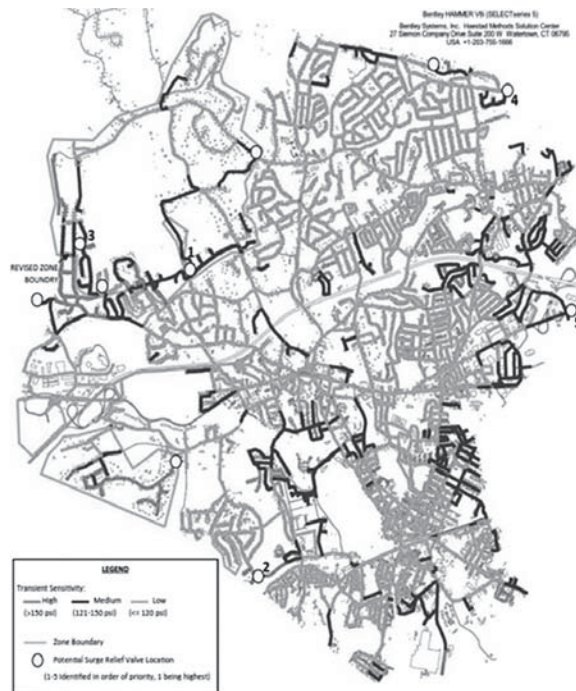
Figure 12. Location of proposed strategic surge relief valves

Recommended improvements to mitigate transients from occurring included installation surge relief valves. BETA found that putting in strategic surge relief valves, designed to open automatically to alleviate pressure changes associated with a transient, would minimize the pressure and possibly prevent the occurrence of a break. A total of ten locations were identified across three pressure zones. Four locations in the Beebe zone along the Town zone boundary, one location

in the Goodnow Zone, and five locations in the Town Zone were identified.

BETA has prioritized the first five recommended implantation locations. The Town is planning to implement the first strategic surge relief valves in the coming year with a plan to add surge relief valves in order of importance. Figure 12, Location of Proposed Strategic Surge Relief Valves, shows both the locations of proposed surge relief valves and their order of importance..

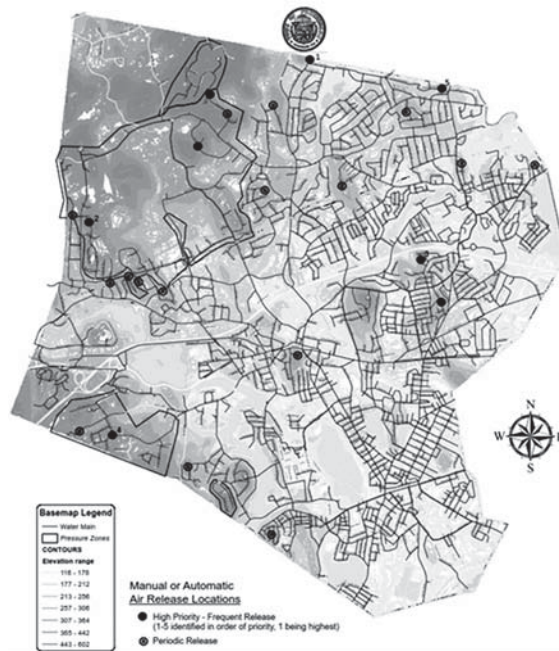
BETA also made recommendations for strategic air release from the system. Air release would improve capacity issues and reduce water hammer concerns (See Figure 13, Manual or Automatic Air Release Locations). The Town is naturally hilly, with the highest elevation located in the Northwest corner of the community. These topographic changes mean that air pockets naturally develop as the water main pipes follow the topographic landscape throughout the Town, and there are a large number of localized high points across Town.

Air pockets in the system can contribute to incidents of transients. As a pressure wave hits an air pocket, it is unable to push through the air, and reflects back in the direction from which

Figure 13. Manual or automatic air release locations

it came potentially leading to higher pressures. Without the air pocket, the wave stands a chance of naturally dissipating or of reaching a strategic surge valve and forcibly dissipating. The Town does not yet have a plan to move forward with installation of air valves, but is developing an air release strategy as part of regular maintenance. The Town plans to bleed air out of the system during routine flushing work. Either strategy will help reduce the impact of water hammer and may in turn be expected to reduce the incidence of water main breaks..
